NATIONAL ADVISORY COMMITTEE FOR AERONAUTICS

WARTIME REPORT

MEASUREMENTS IN FLIGHT OF THE STABILITY, LATERAL-
CONTROL, AND STALLING CHARACTERISTICS OF AN AIRPLANE
EQUIPPED WITH FULL-SPAN ZAP FLAPS AND
SPOILER-TYPE AILERONS

MEMORANDUM REPORT

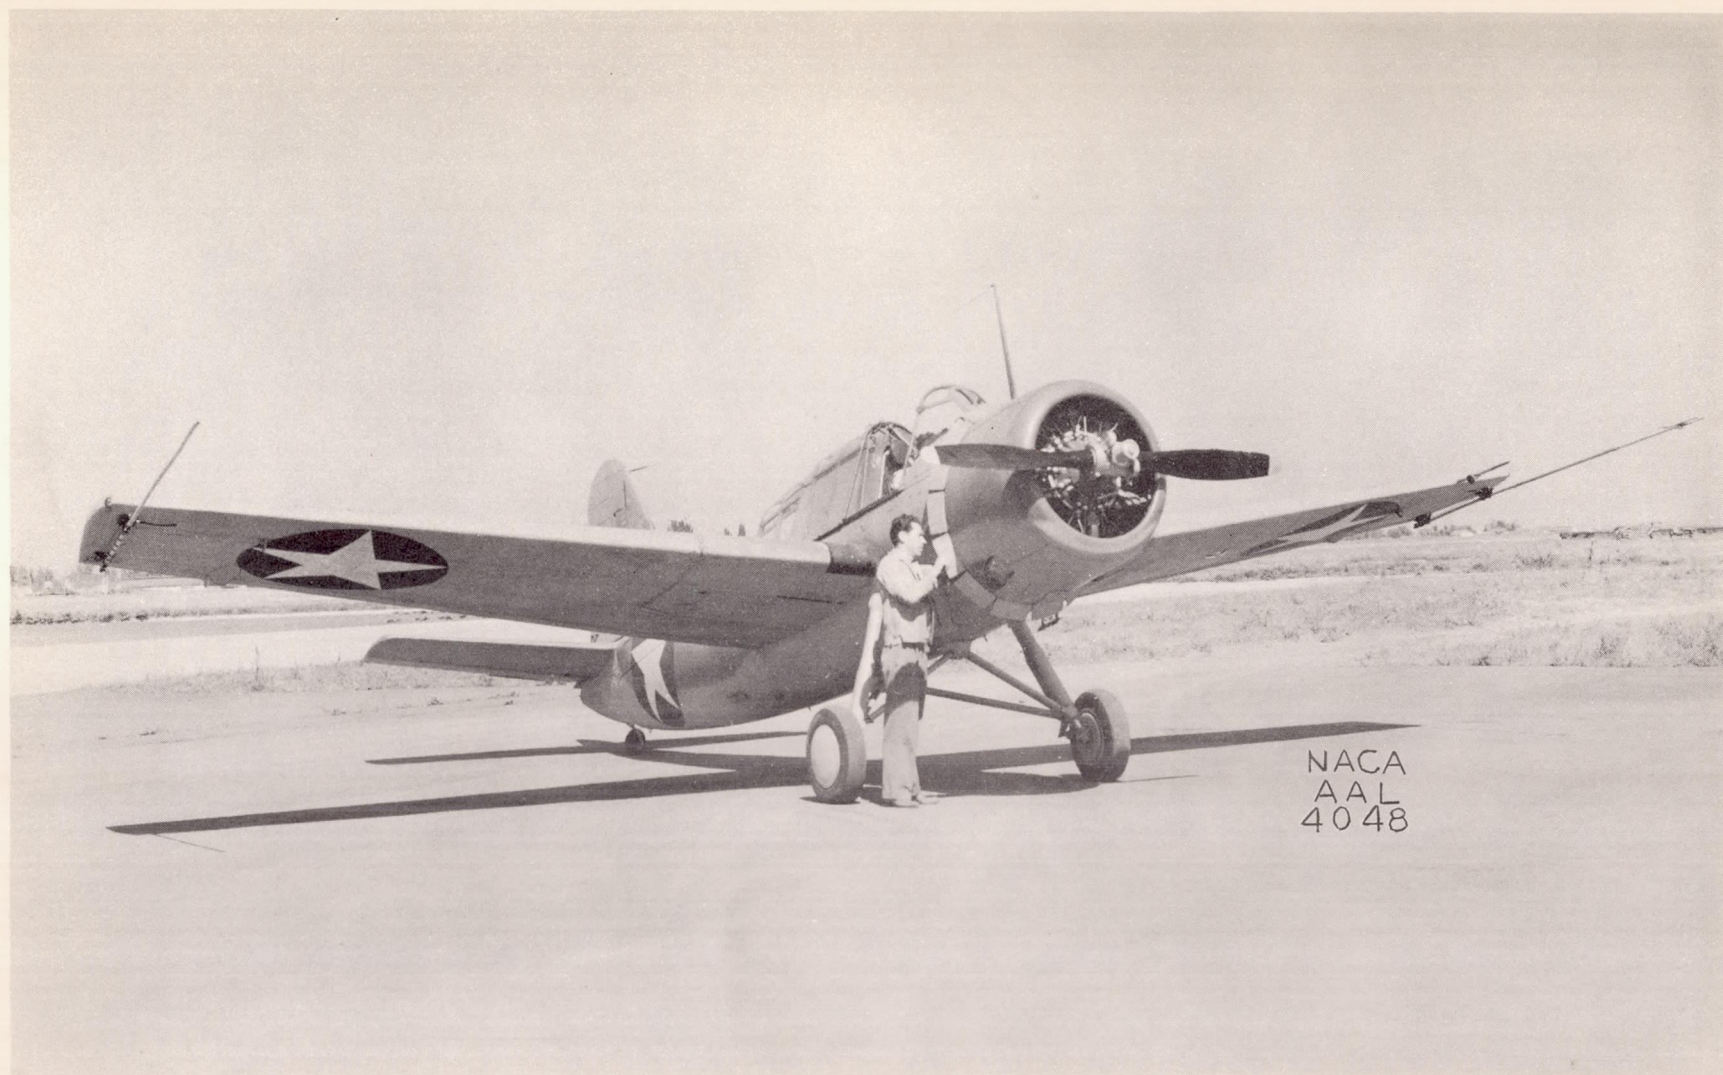
Figure 1. - Front view of the test airplane as instrumented for flight.

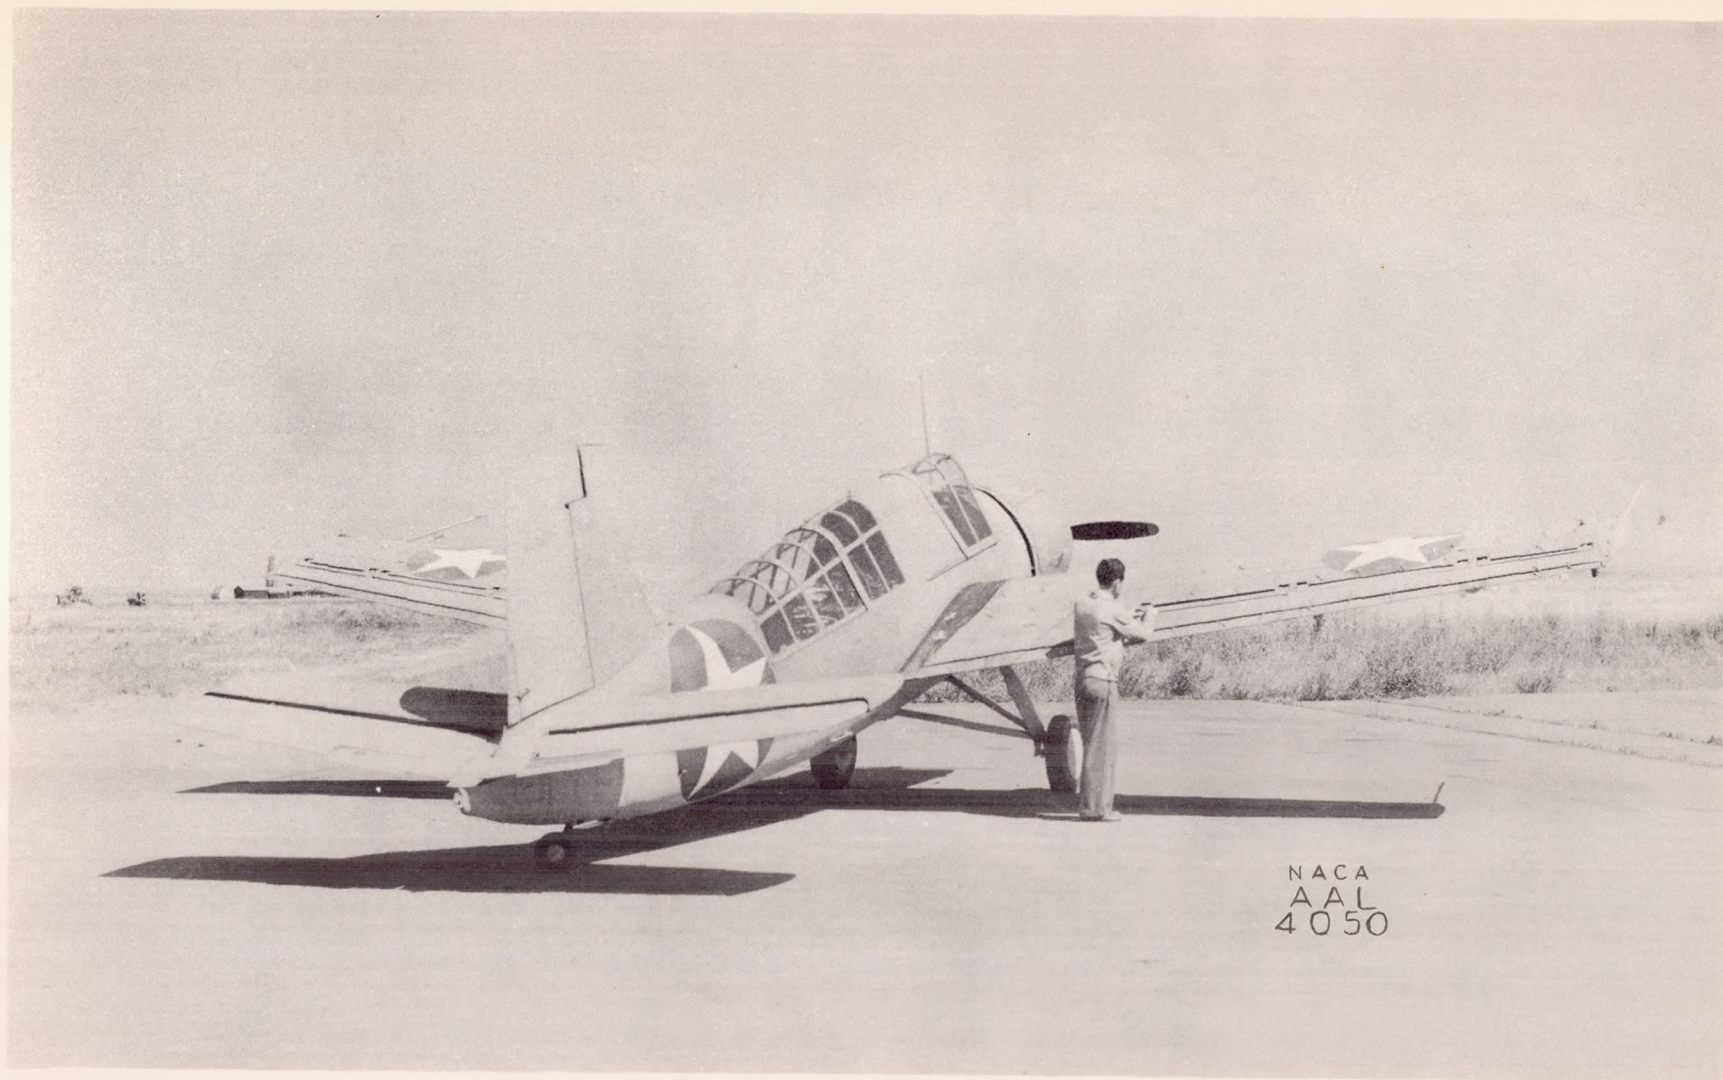
Figure 2. - Rear view of the test airplane as instrumented for flight.

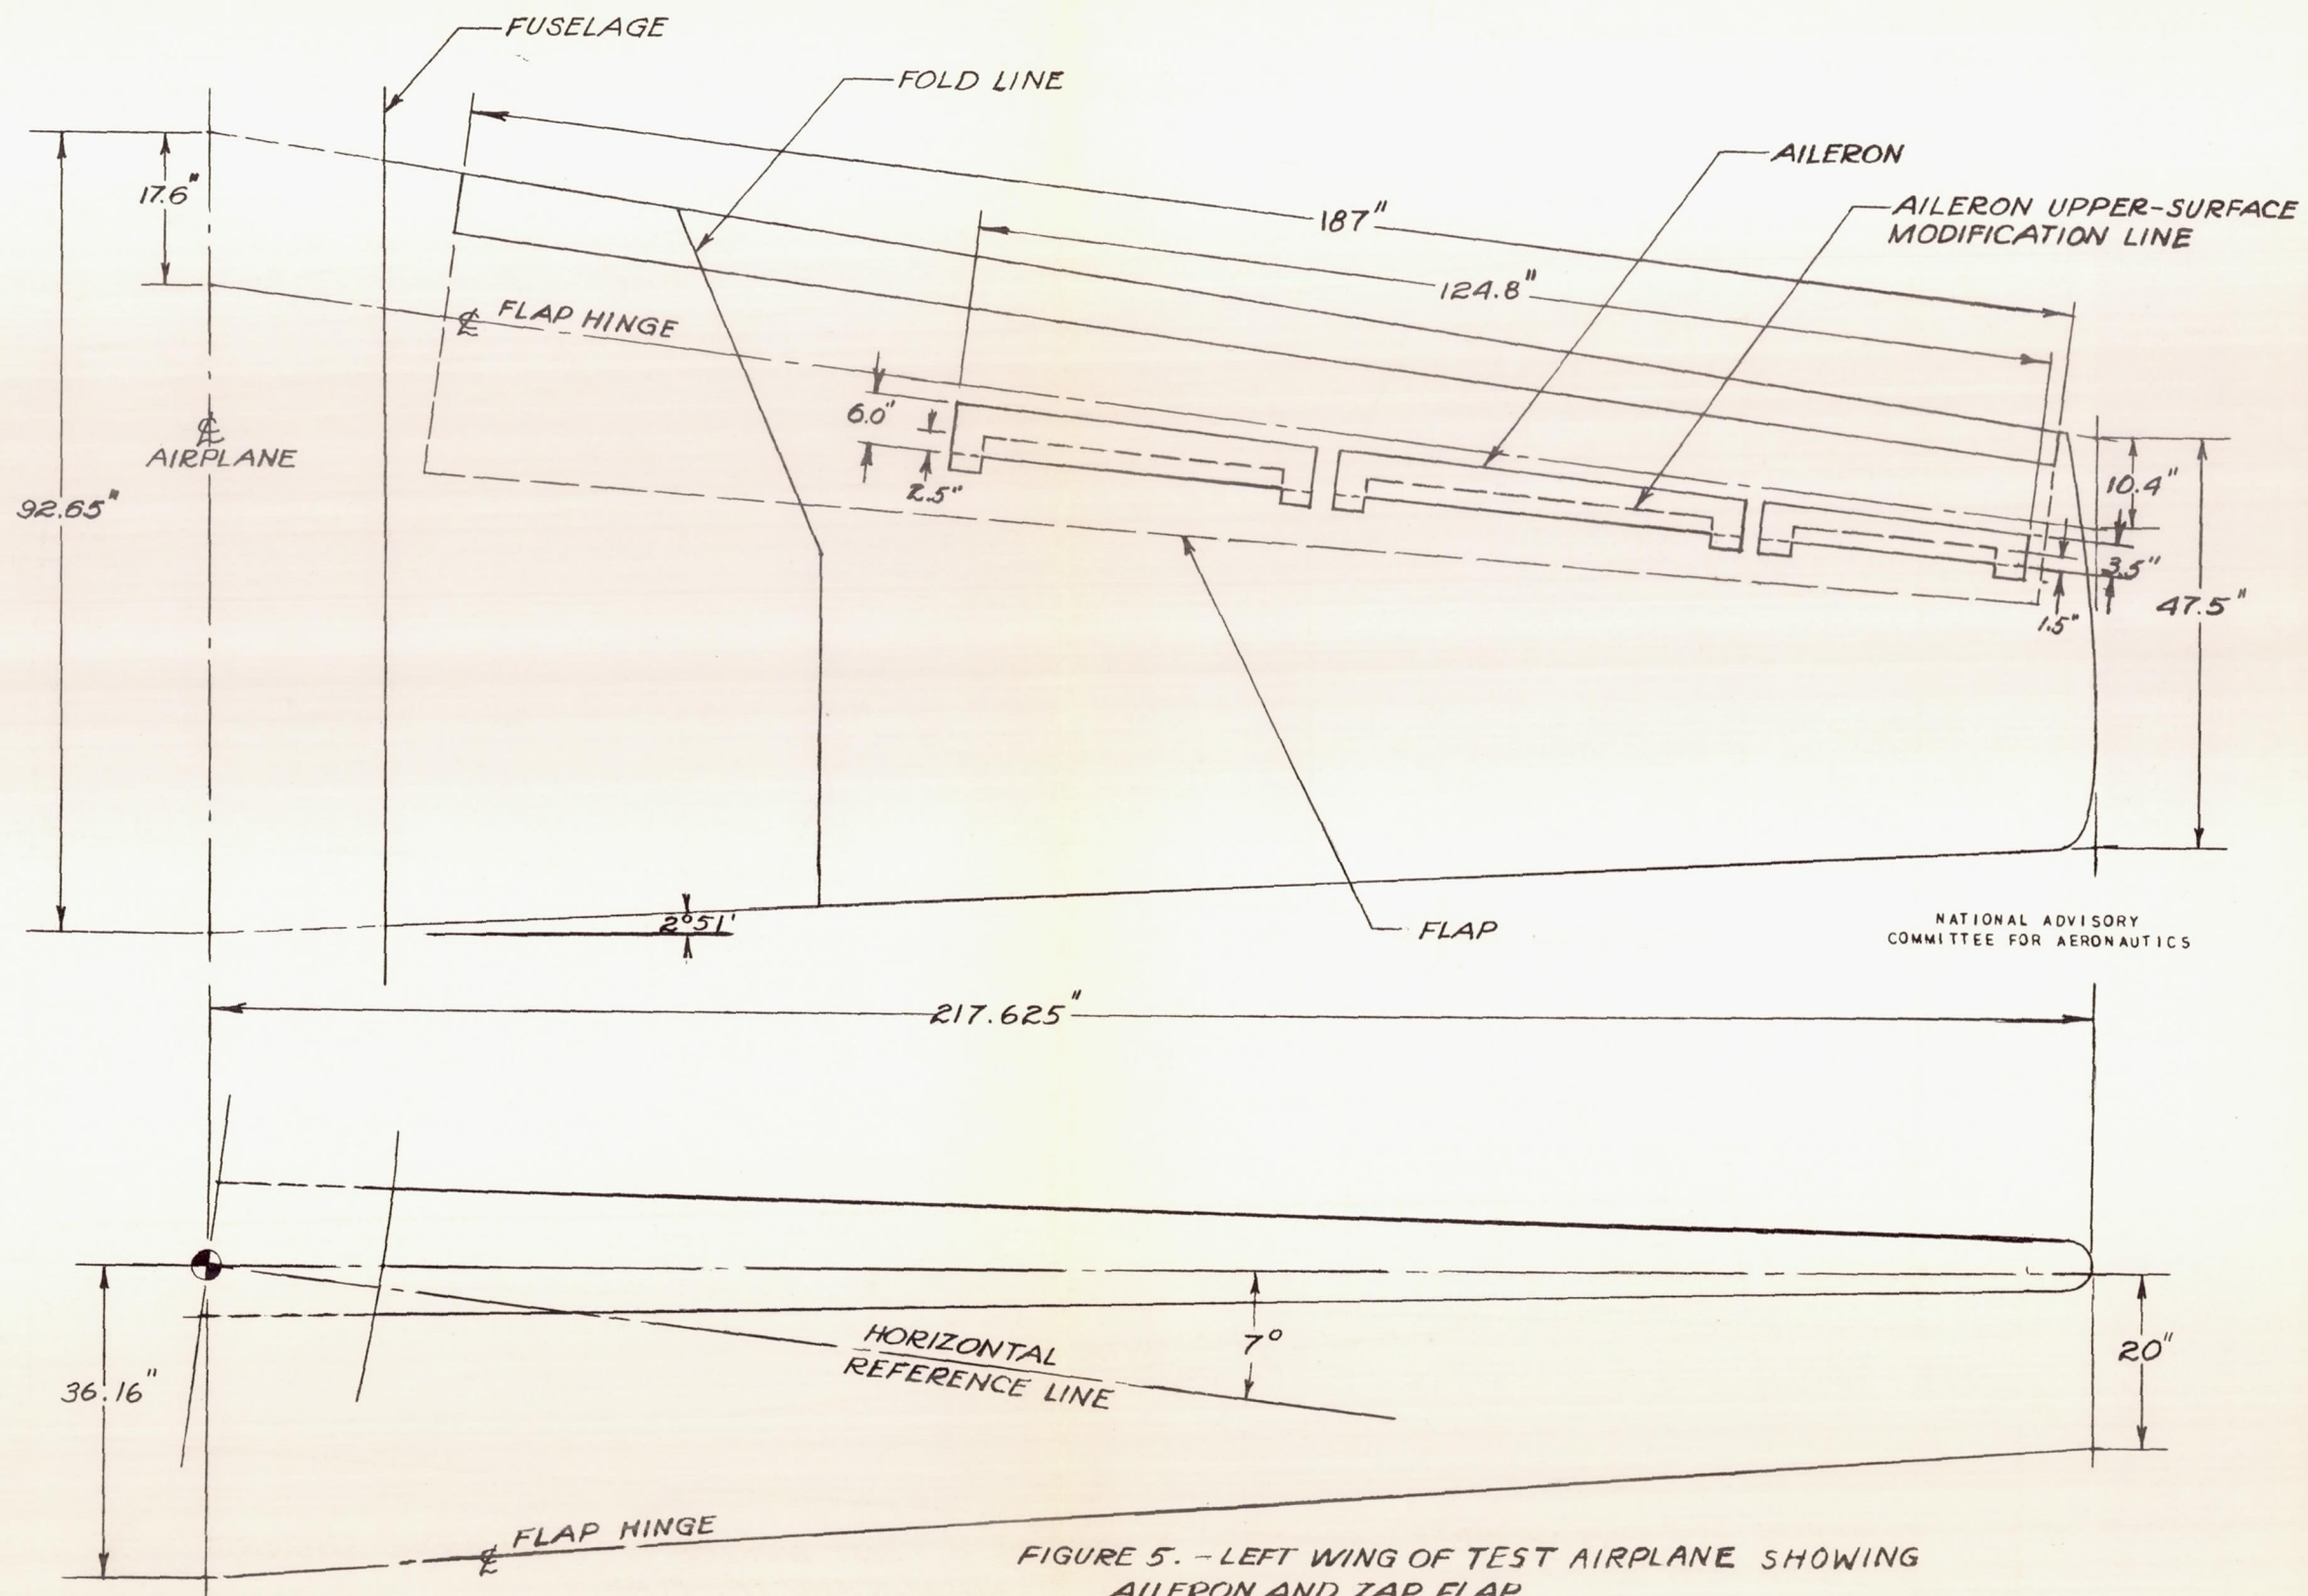
FIGURE 5. - LEFT WING OF TEST AIRPLANE SHOWING AILERON AND ZAP FLAP.

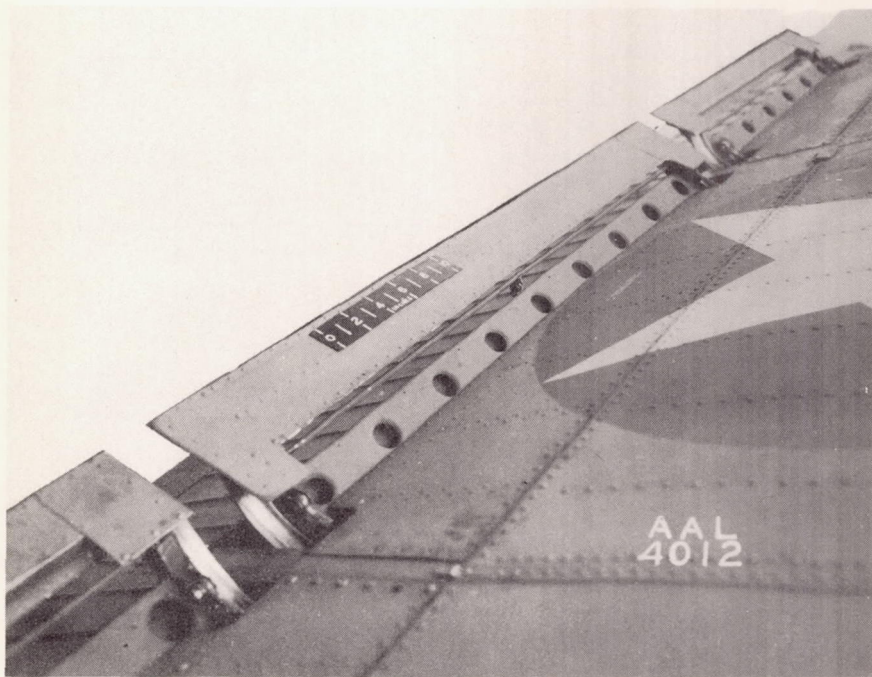
Figure 6. - Left-central aileron panel in original condition
with vane in neutral position.

The upper-surface ailerons, shown in their original condition in figure 6, are actuated by the lateral-control system, as shown in figure 8. The ailerons operate in tracks located within the wing structure and, when actuated by the control system, deflect about a center of rotation exterior to the wing surface. The aileron differential linkage located in the fuselage is shown in figure 9 for two positions of the control stick. The lateral-control system includes a small vane located beneath each aileron surface in the spanwise gap created between the aileron surface and the upper wing surface by deflecting the ailerons (fig. 6). These vanes are adjustable

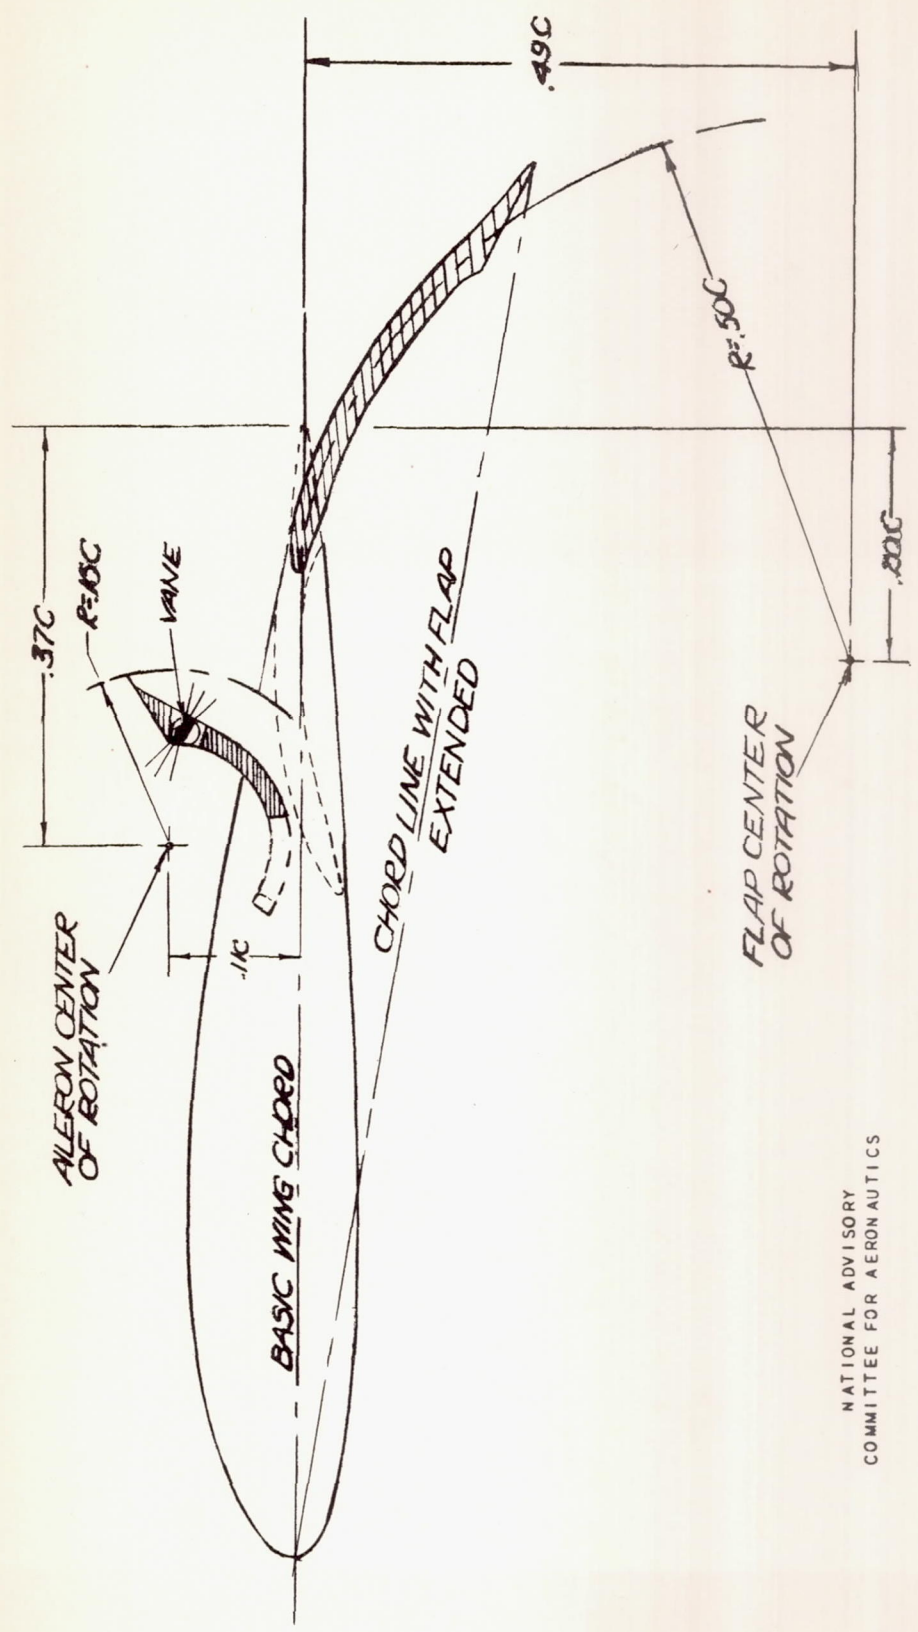
FIGURE 7. — CROSS-SECTIONAL DRAWING OF THE WING
SHOWING THE AILERON AND FLAP EXTENDED
AND RETRACTED.

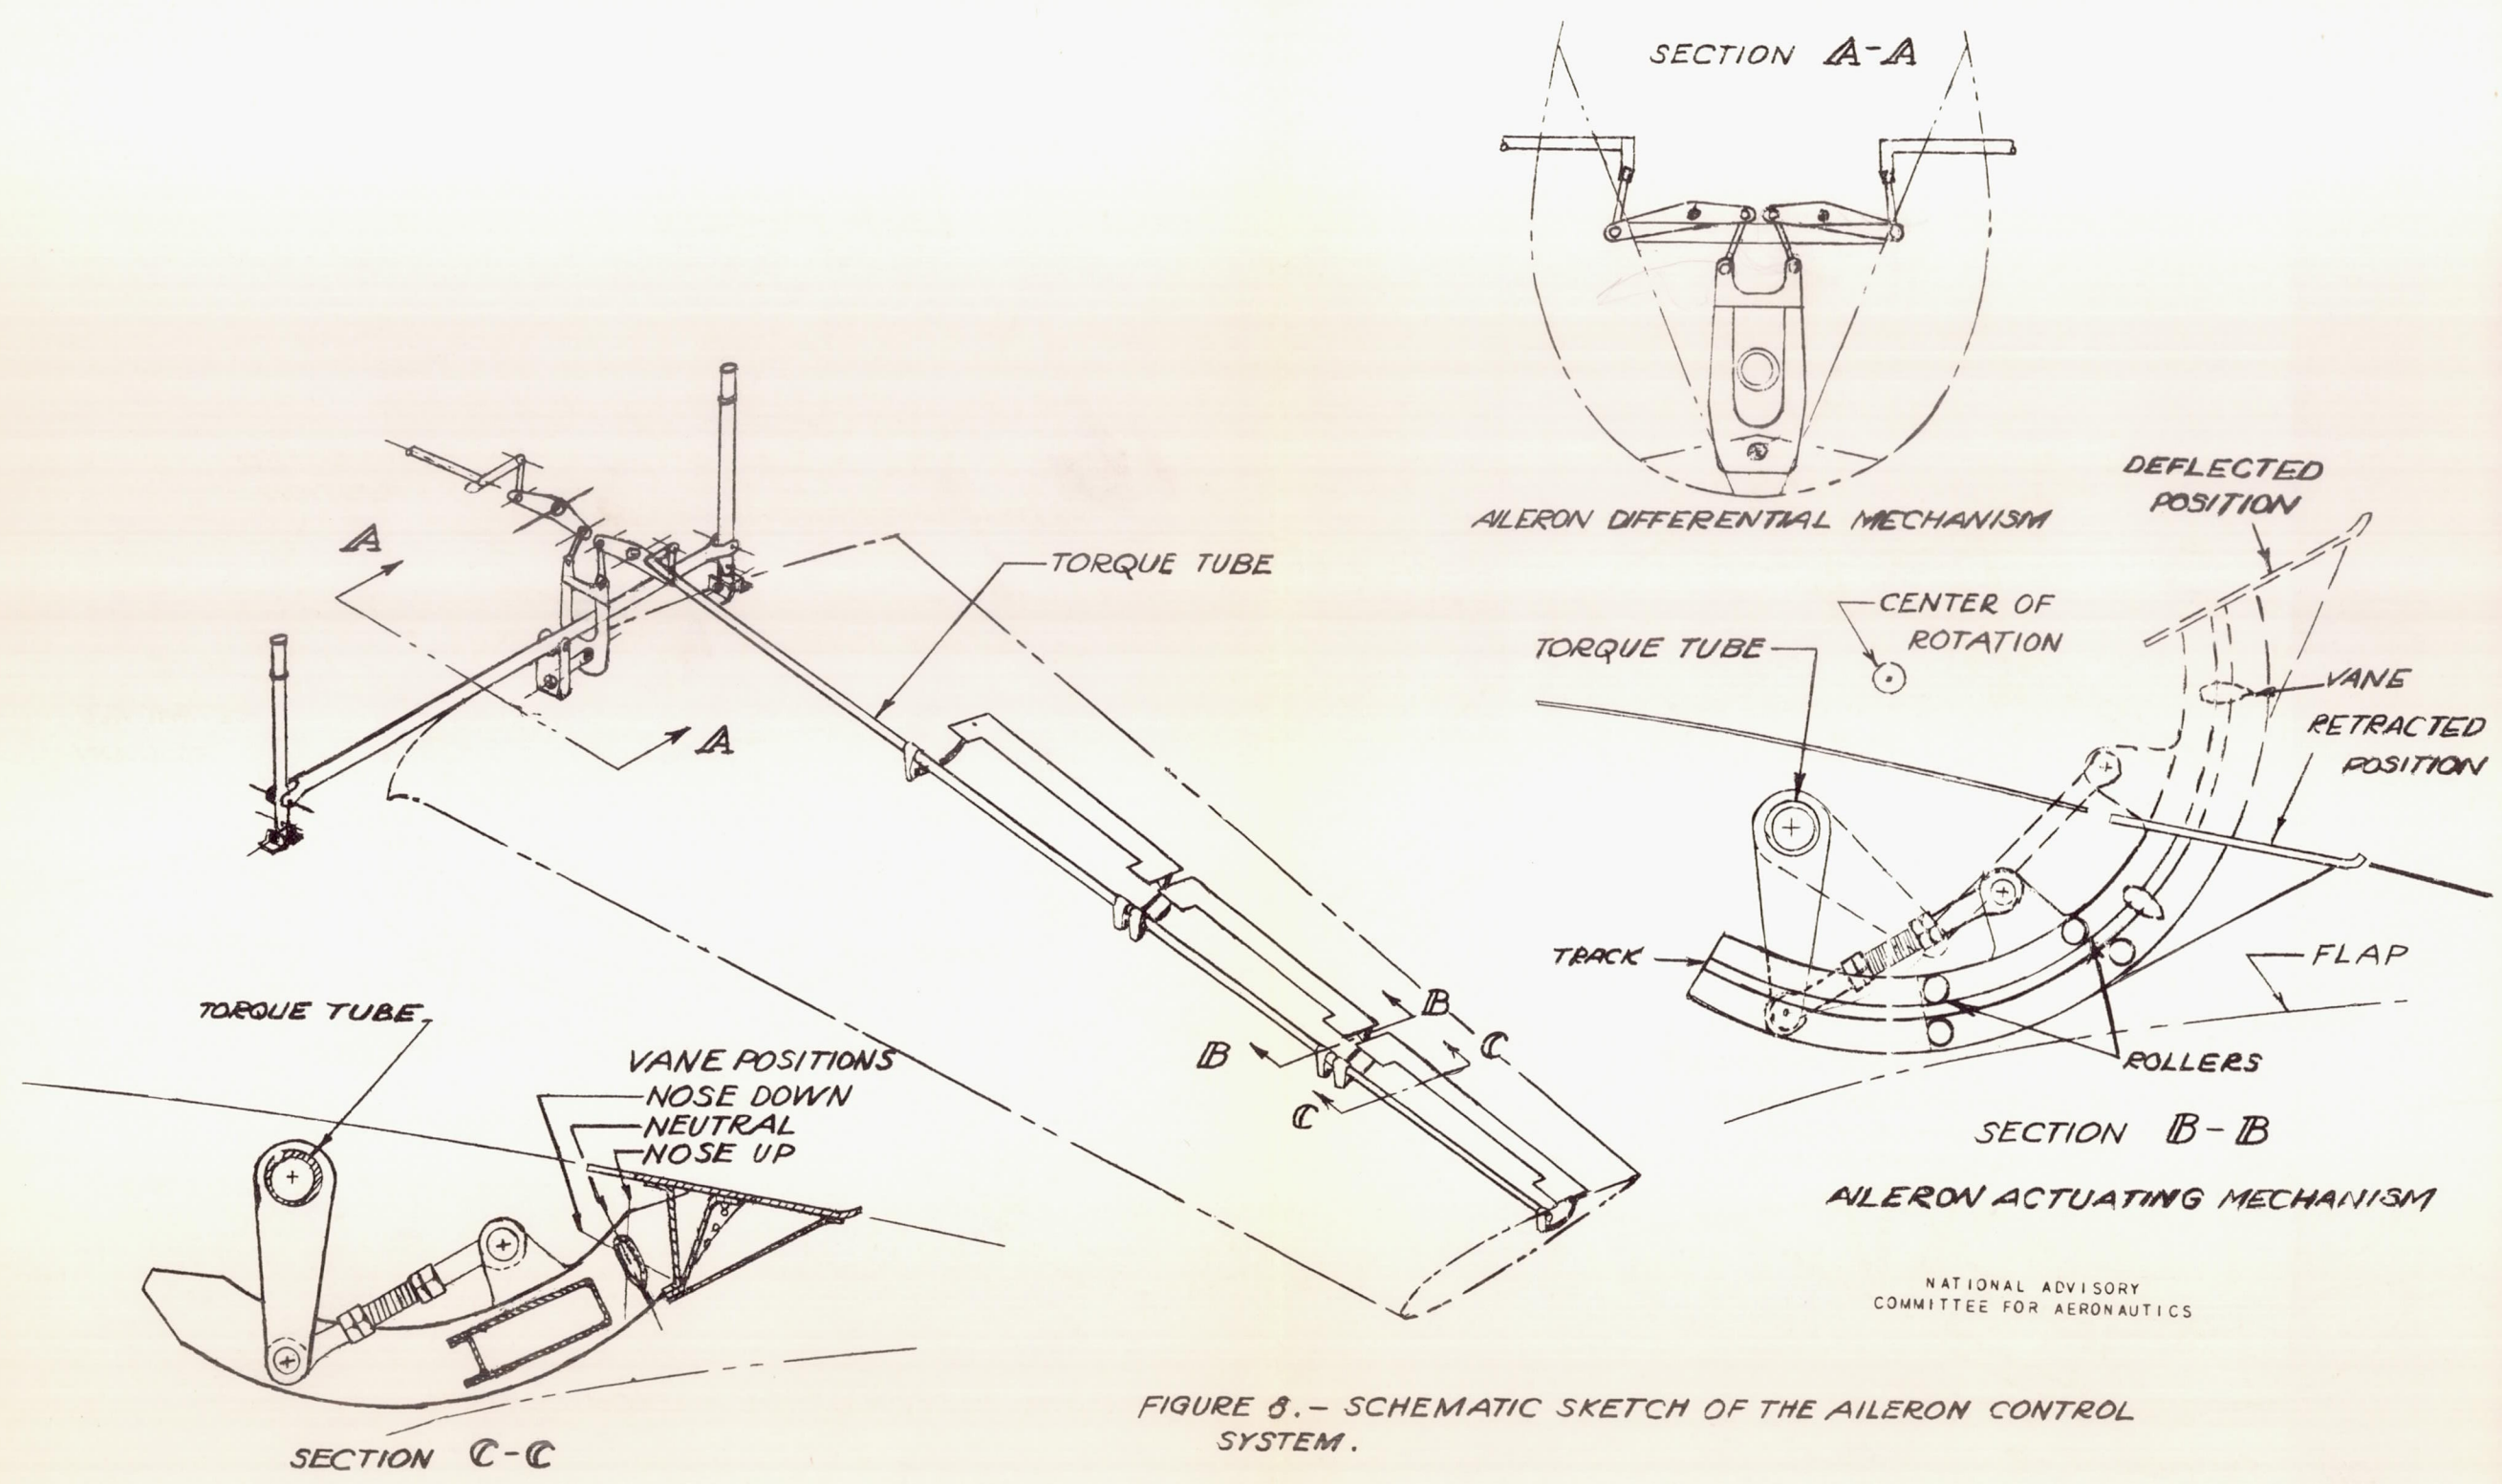
FIGURE 8. - SCHEMATIC SKETCH OF THE AILERON CONTROL SYSTEM.

in pitch at three positions: nose-up, neutral, and nose-down as indicated in figure 8. The purpose of the vanes is to regulate the lateral-control forces. The vanes were set in the nose-up position for the original test condition.

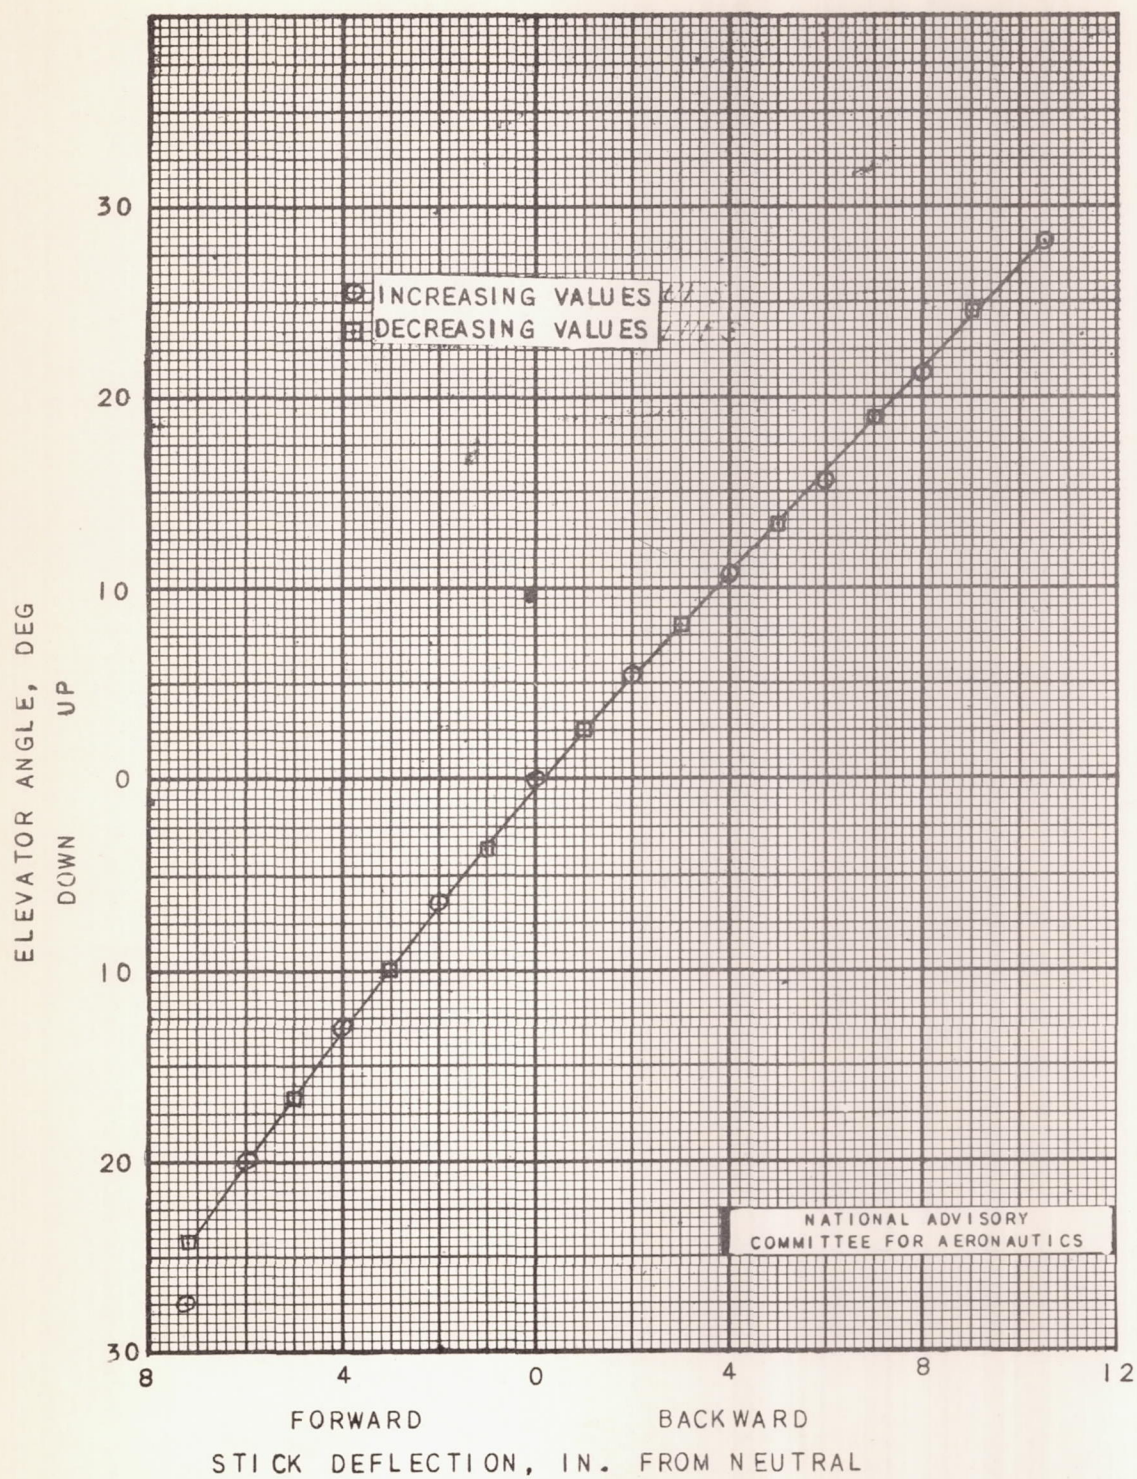
FIGURE 10. - VARIATION OF ELEVATOR ANGLE WITH STICK DEFLECTION.

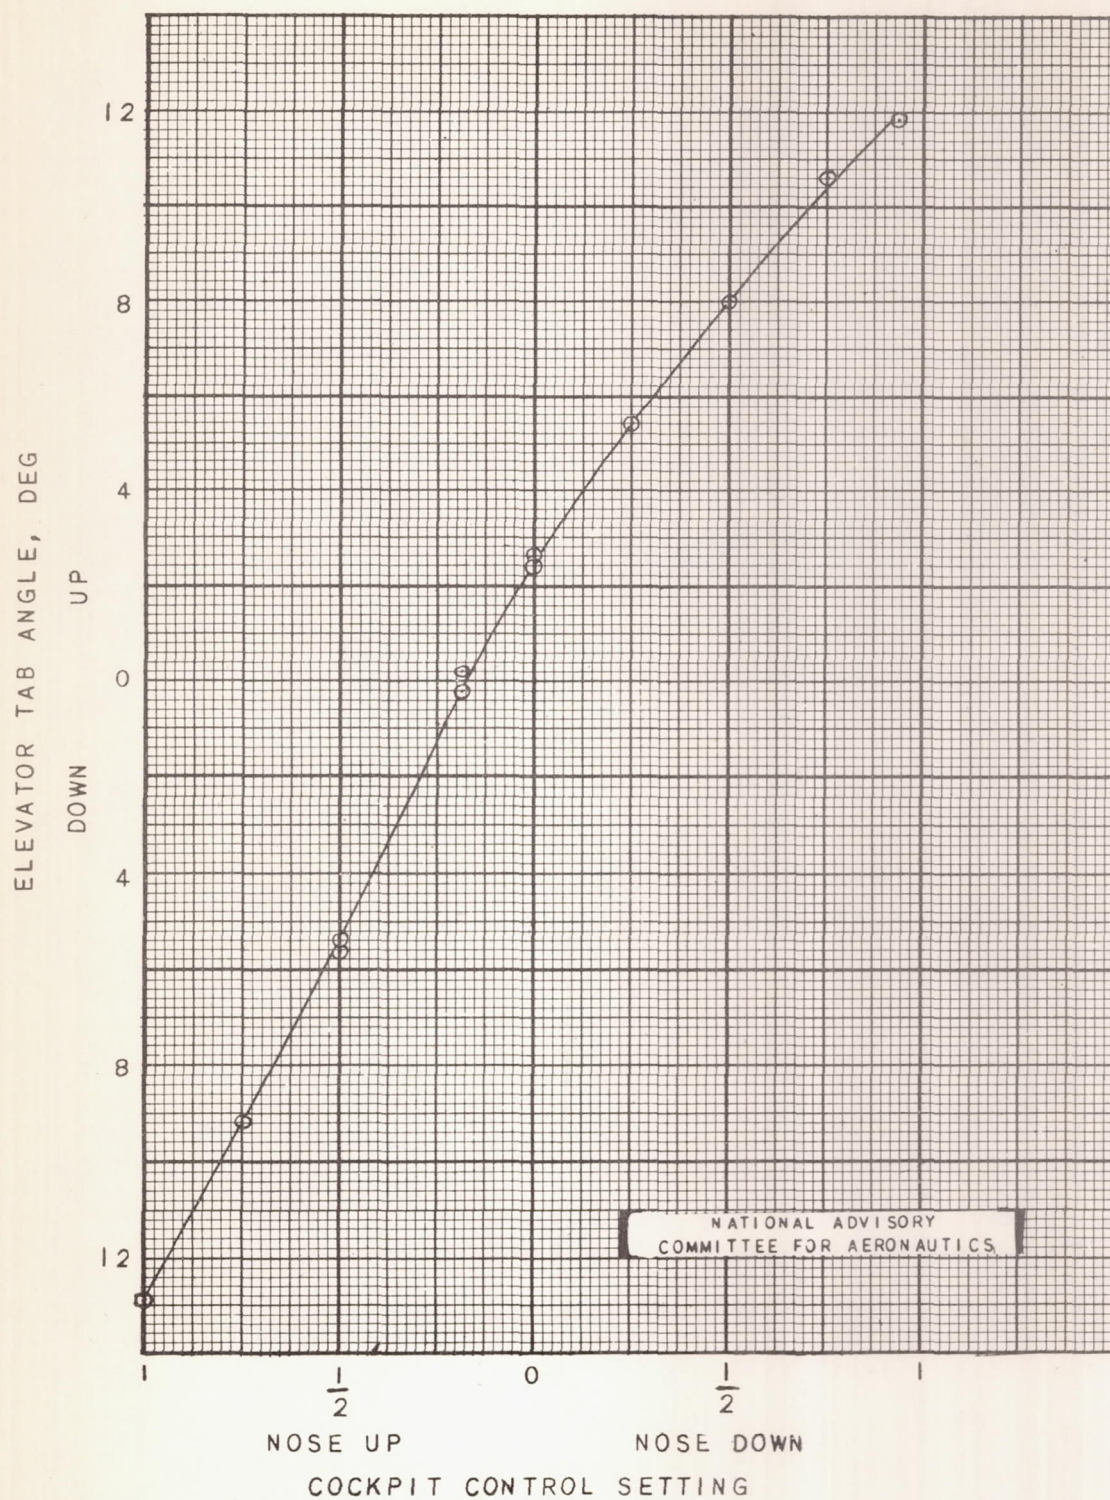
FIGURE II. - VARIATION OF ELEVATOR TAB ANGLE WITH COCKPIT CONTROL SETTING.

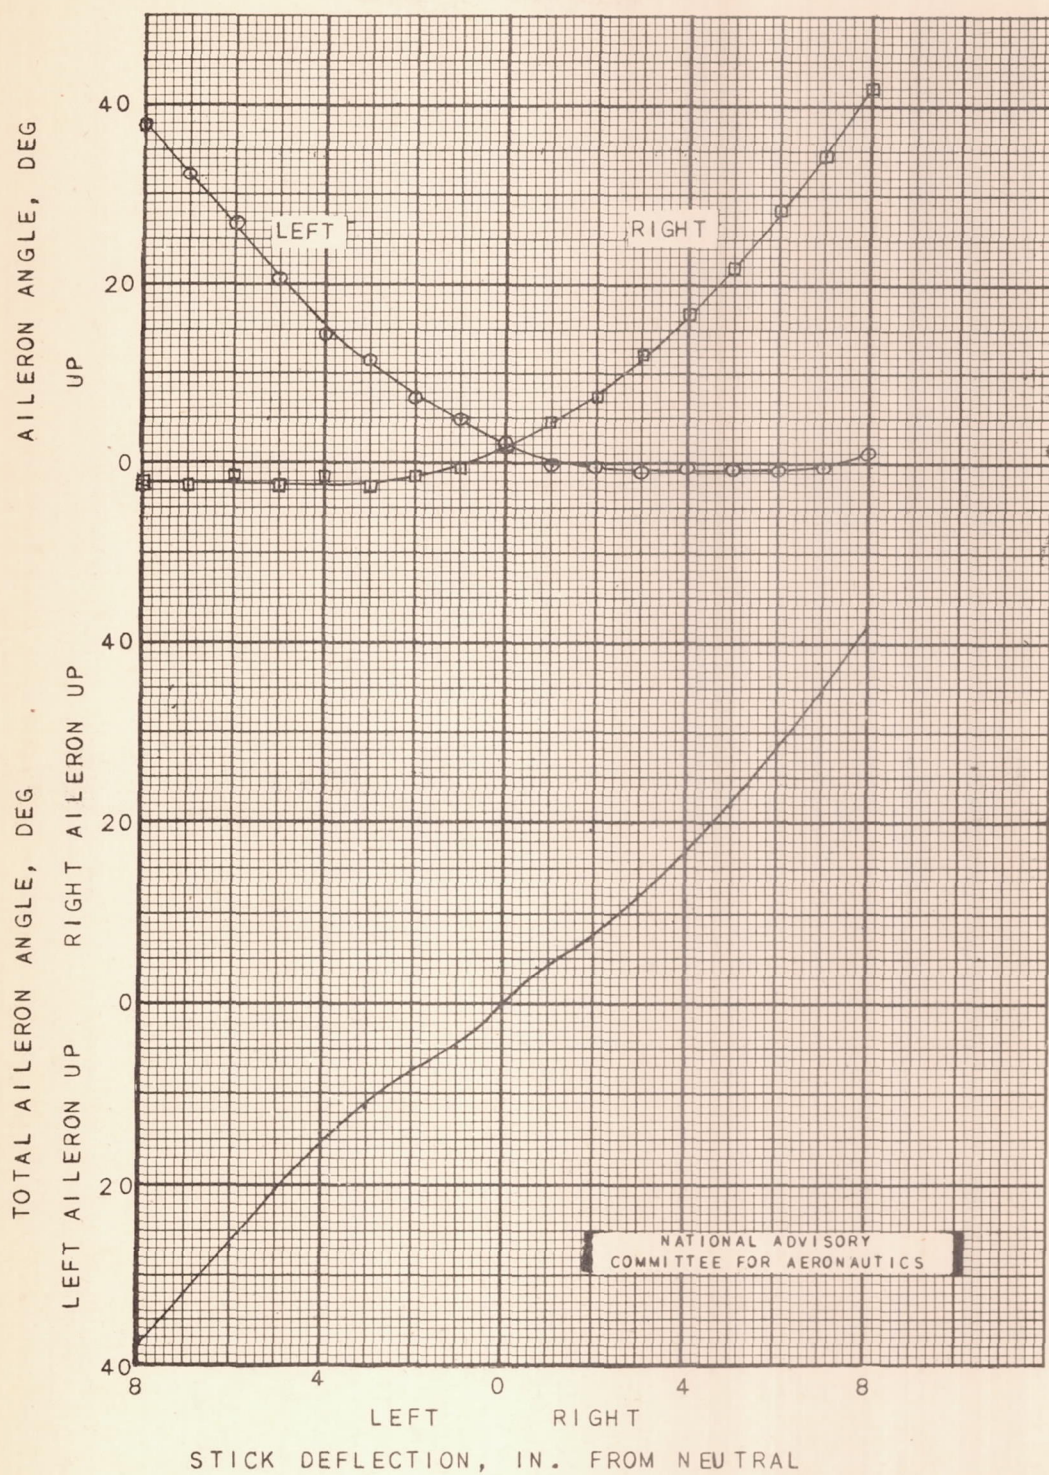
FIGURE 12. - VARIATION OF AILERON ANGLE WITH STICK DEFLECTION.

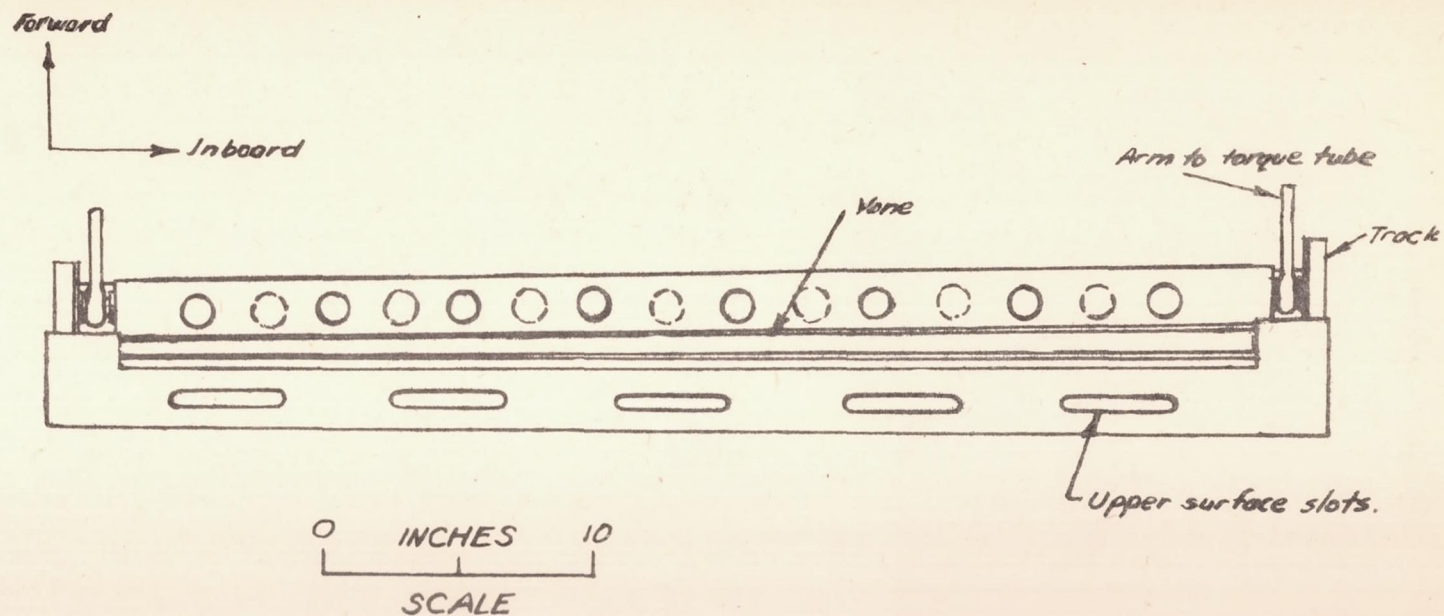
FIGURE 14- SKETCH OF A TYPICAL AILERON PANEL
WITH MODIFIED UPPER SURFACE.

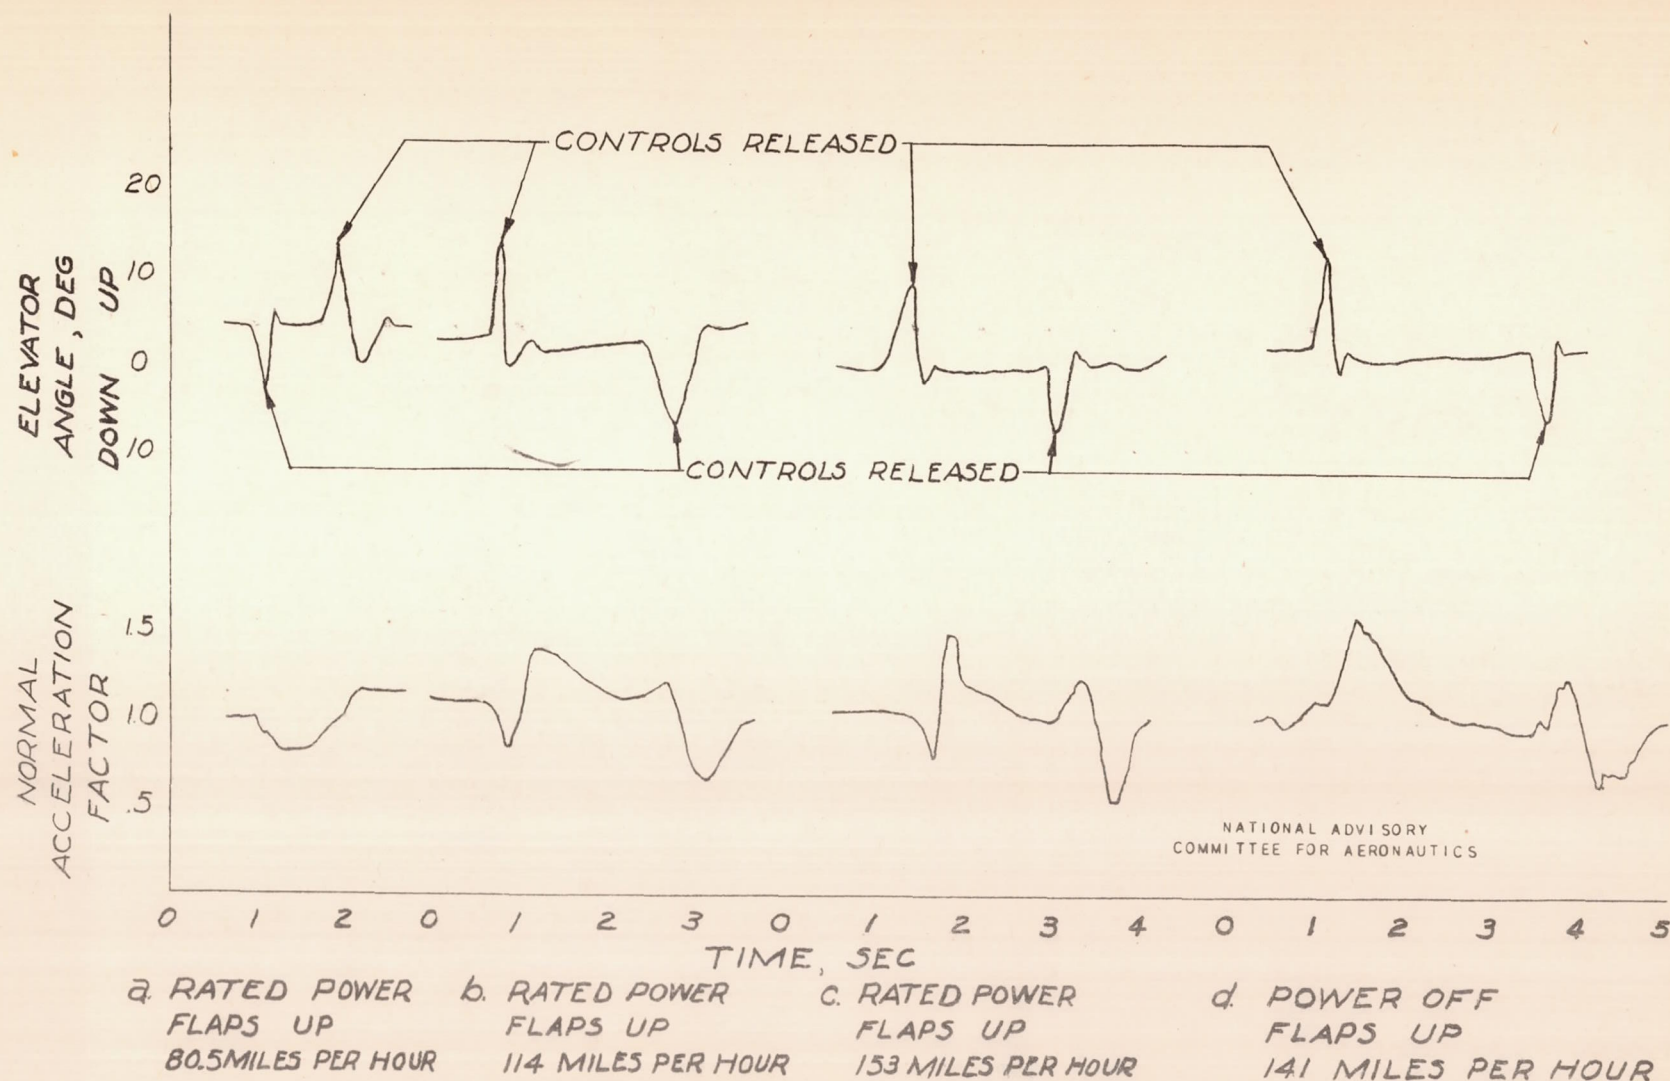
FIGURE 15. — CHARACTERISTICS OF UNCONTROLLED LONGITUDINAL MOTION.

Characteristics of uncontrolled longitudinal motion.— From the time histories of the short-period oscillations shown in figure 15, it is observed that in every condition investigated the oscillation of elevator angle and normal acceleration following the release of the elevator control completely disappeared after one cycle.
